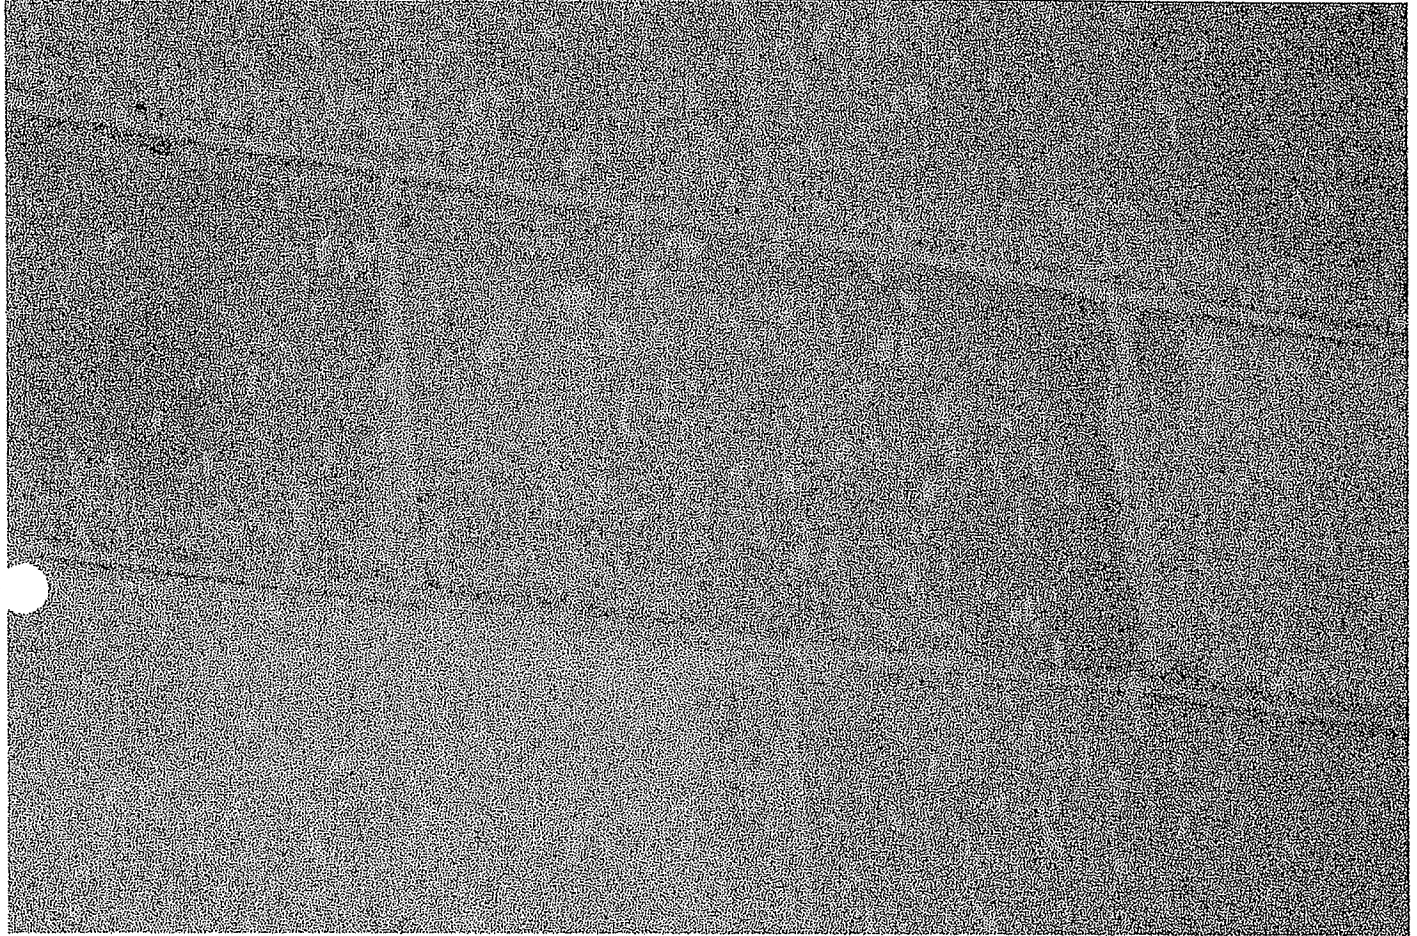
19. rear hall - close-up of overspray on concrete block hallway wall

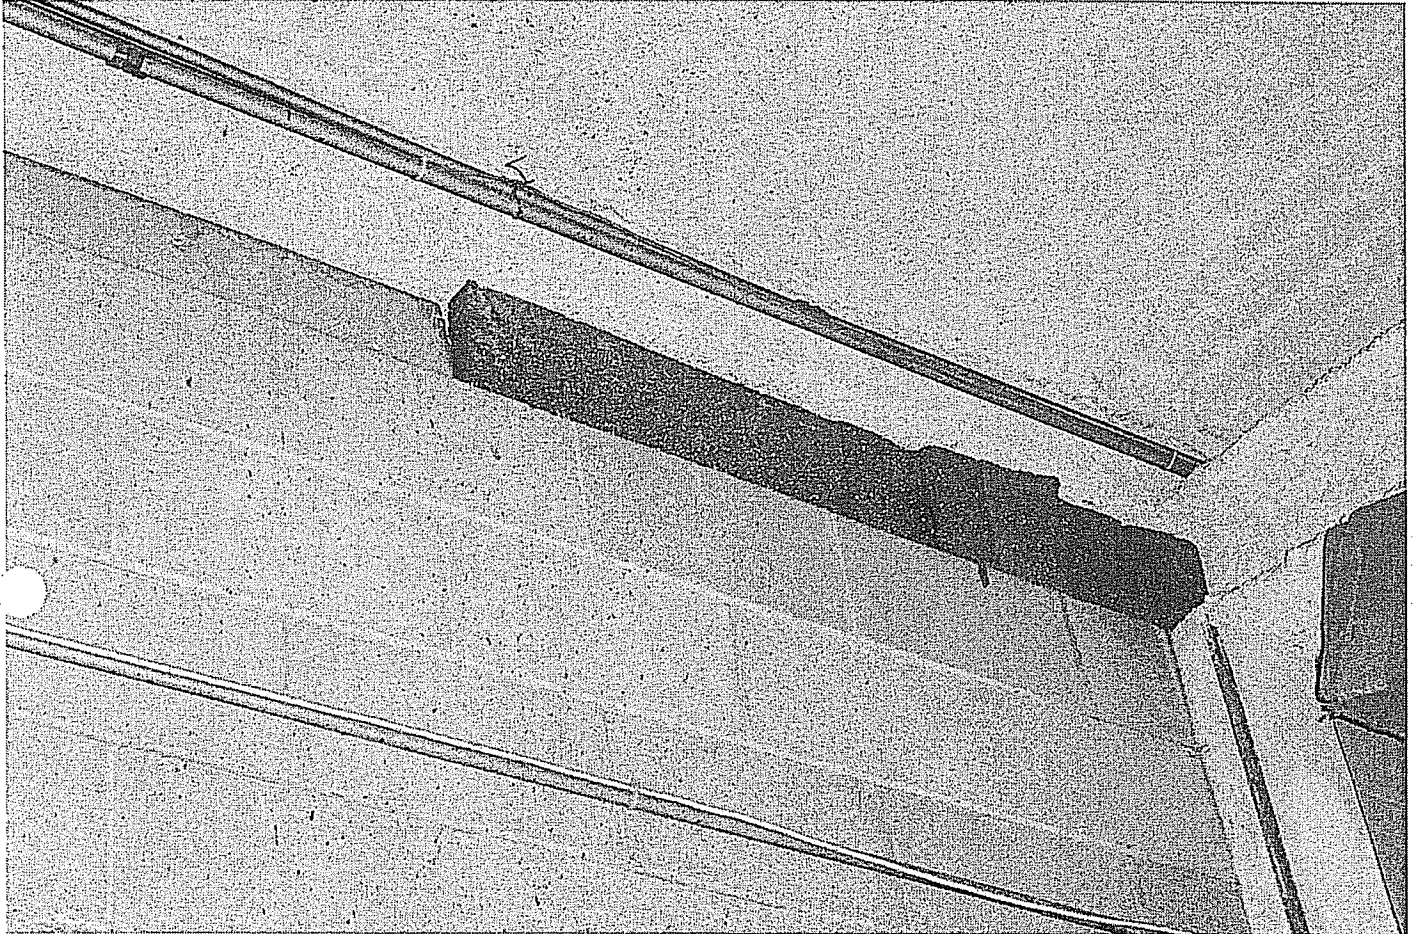
20. offices - material lodged between top of wall and fireproofing deck

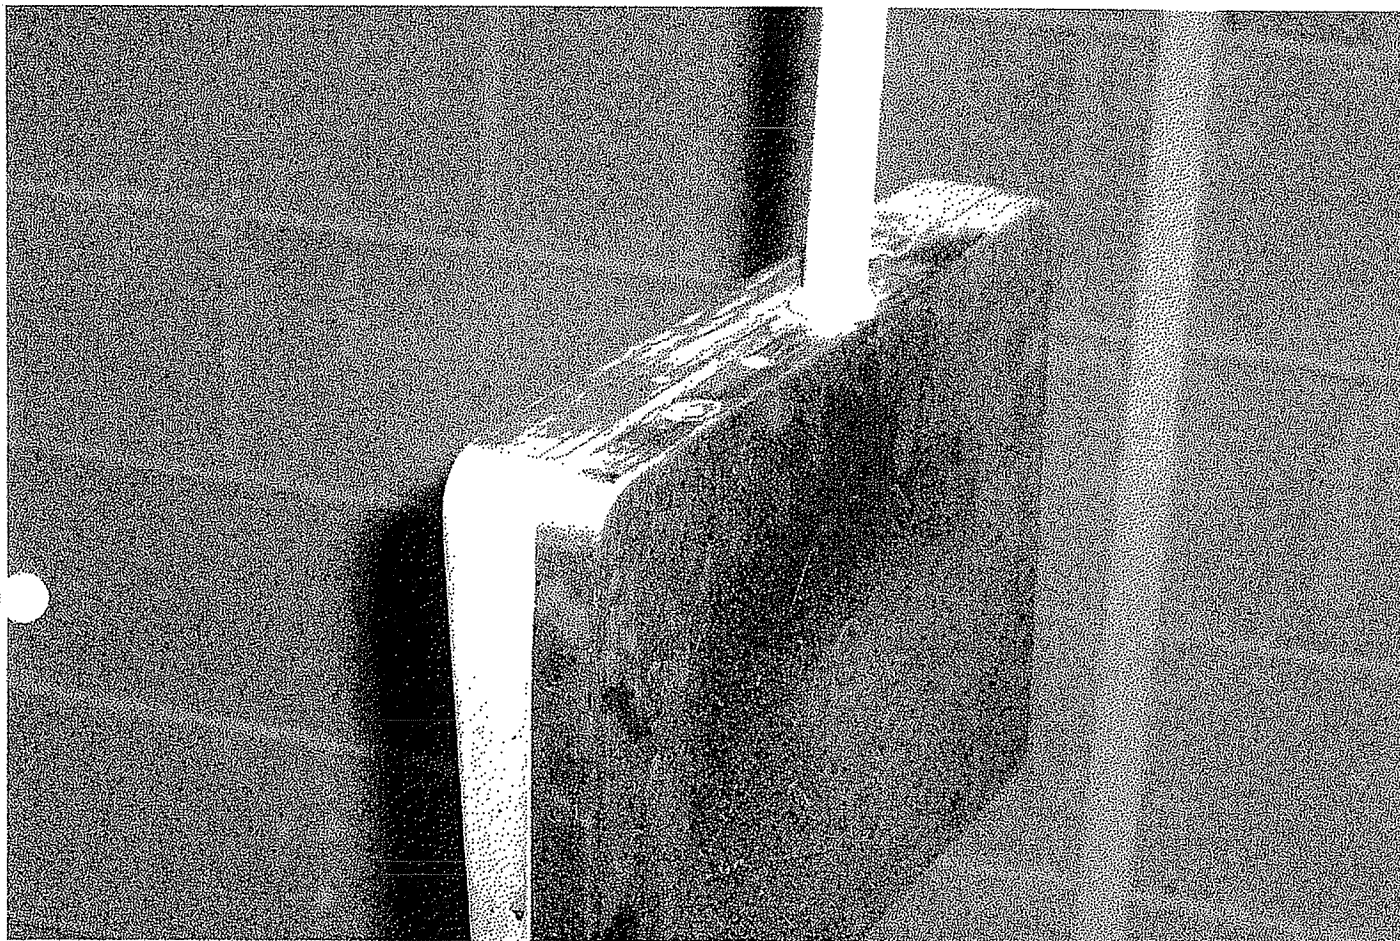
21. rear hall - surface after sampling - location of sample #1

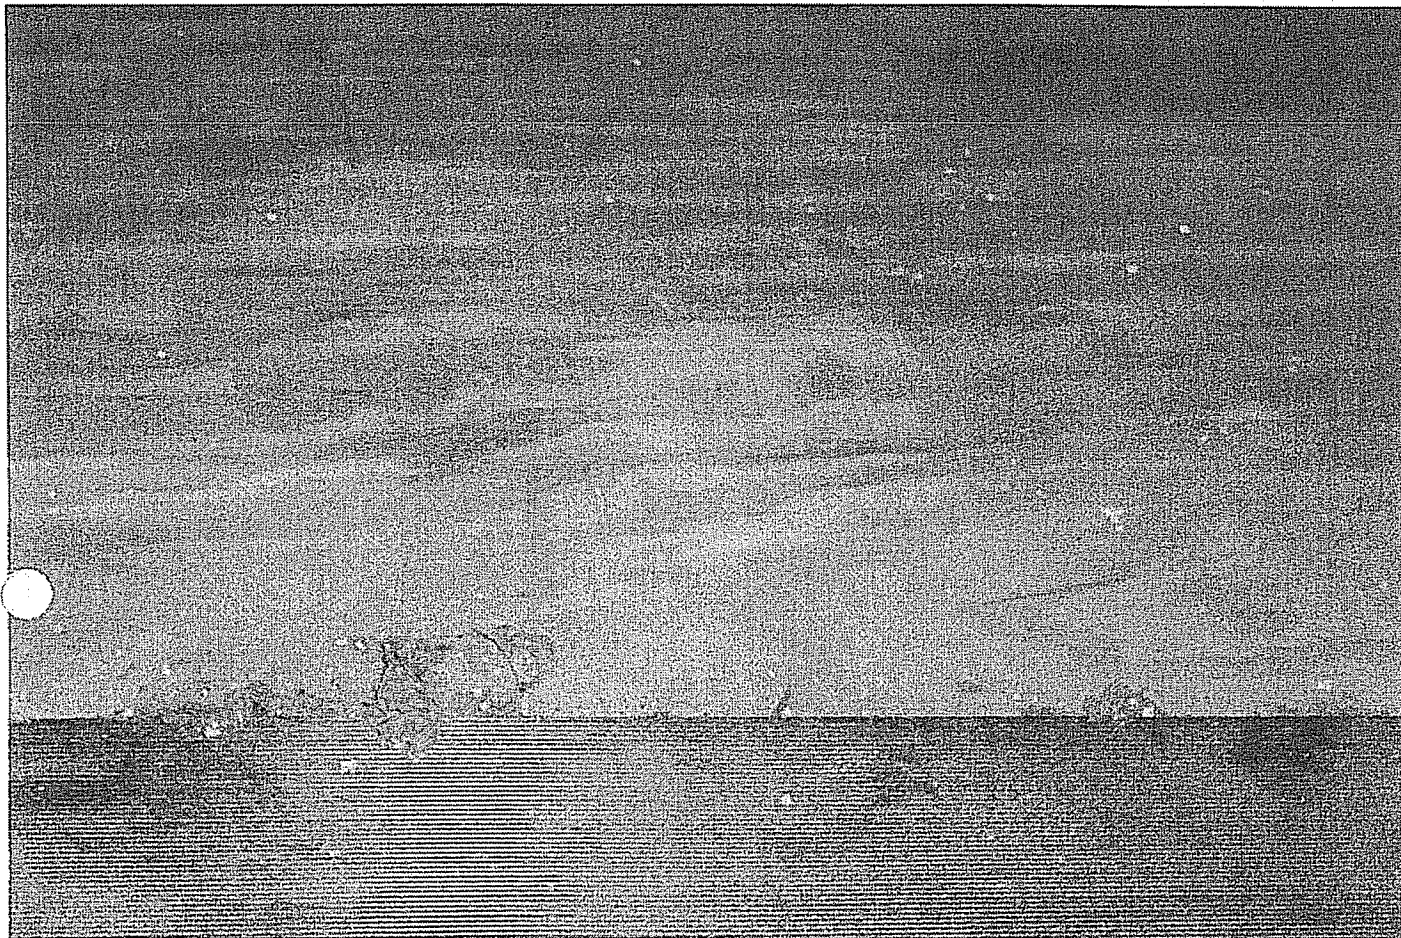
22. plumbing shop - surface after sampling - location of sample #2

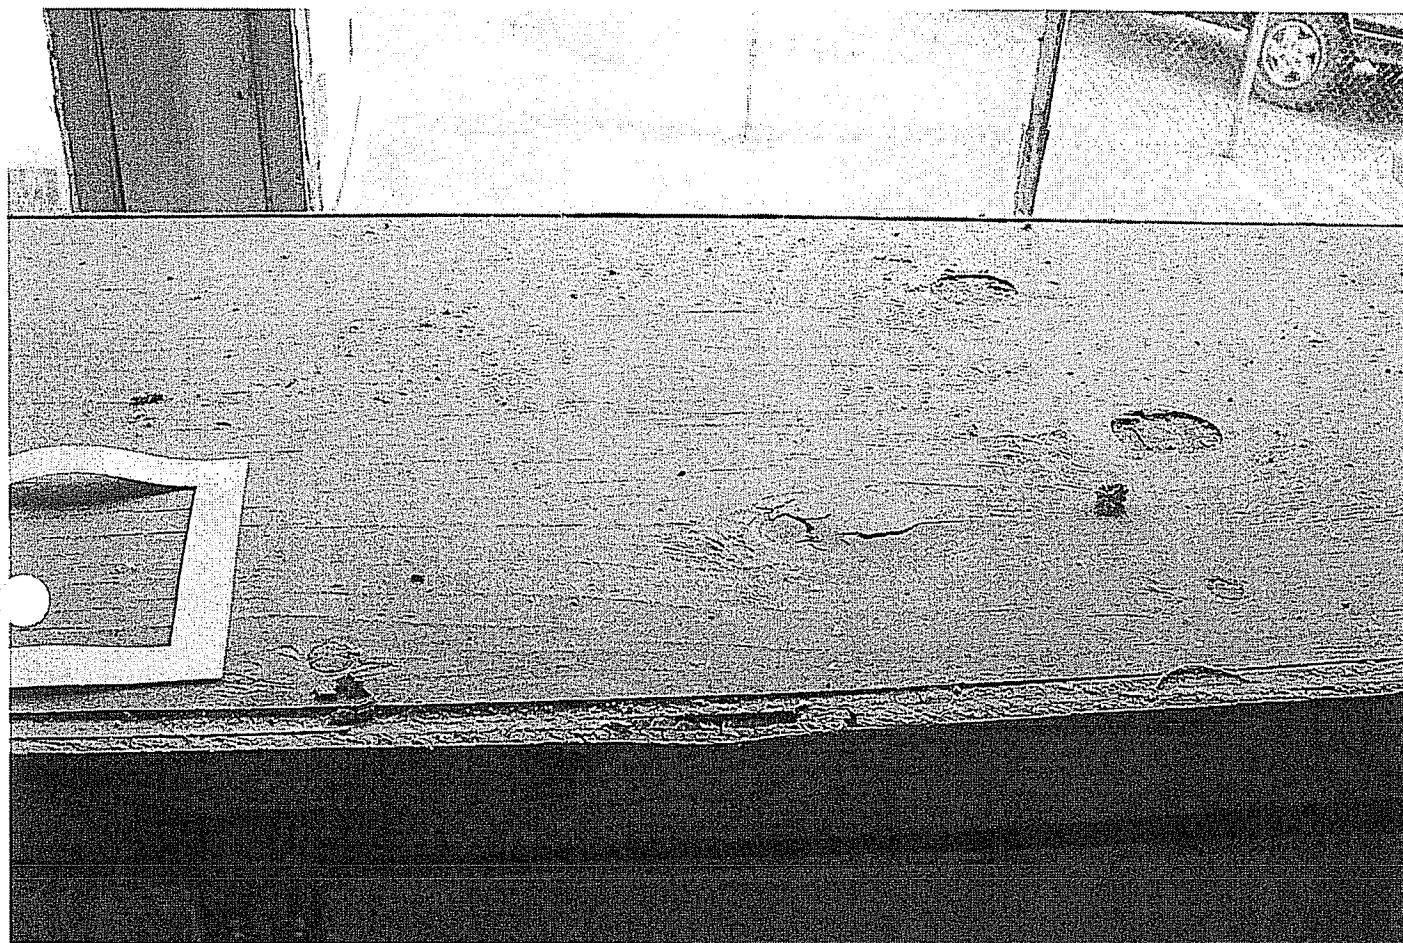
23. paint shop - surface after sampling - location of sample #3

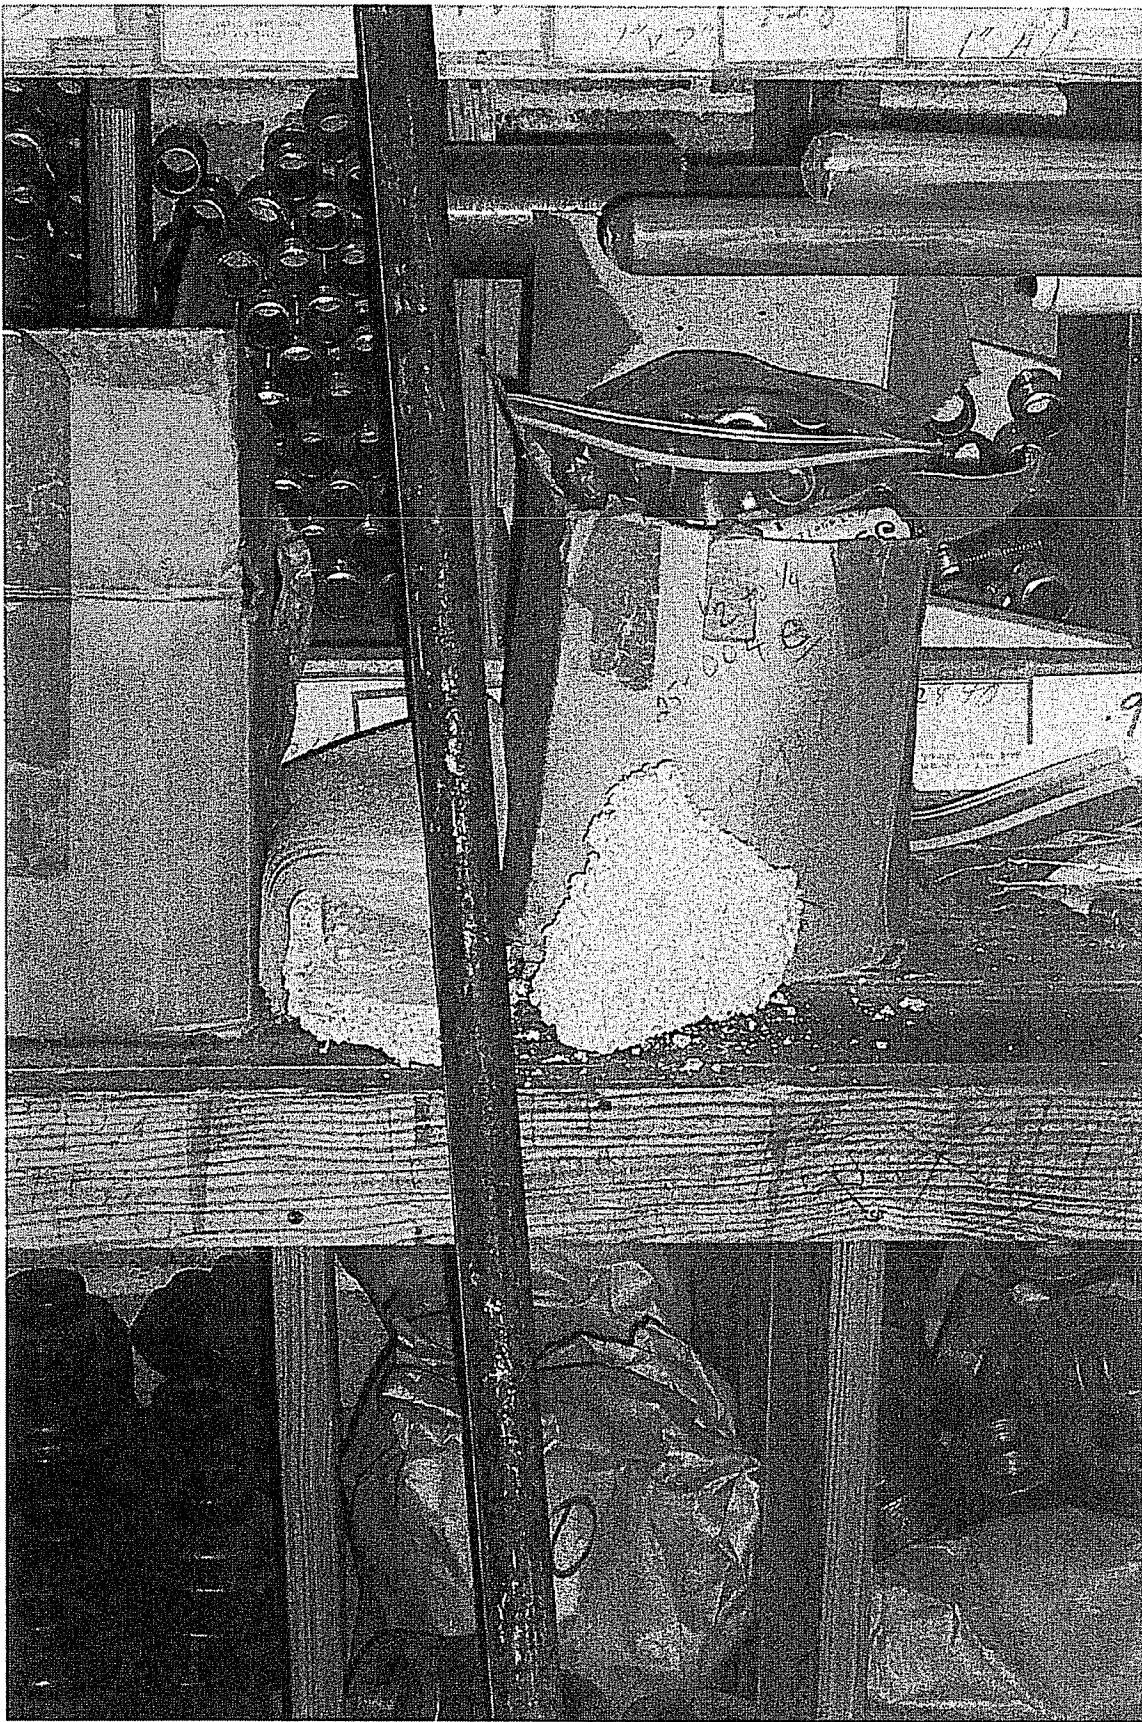
24. parts/stock room - delaminated fireproofing dust and debris along backwall
